# Manhole Inspection Summary

Manhole # S19Y\_\_020MH

Insp Date: **6/2/08 10:02 AM**

**Location** Address: **2021 griffis av**

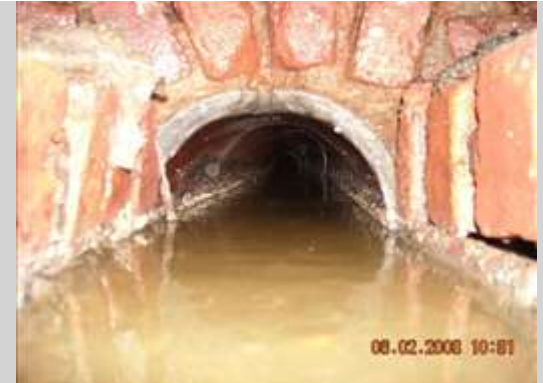
12 O'Clock Outflow

Pipe Height: **8.4** (in.) Rod and Bar (Angled)  
Pipe Material: **Clay** ☐ Pipe Lined  
Invert Depth: **12.94** (ft.) Flow Characteristics: **Slow**  
Deposits: ☒ None ☐ Mud ☐ Sludge ☐ Debris ☐ Grease  
Silt Depth: **0** (in.) Deposits Extent:  
Infiltration: **None** Pipe Seal Cond: **Sound**
